Asa Hall Hancock, July 13th, 1920

By Steve Lutz

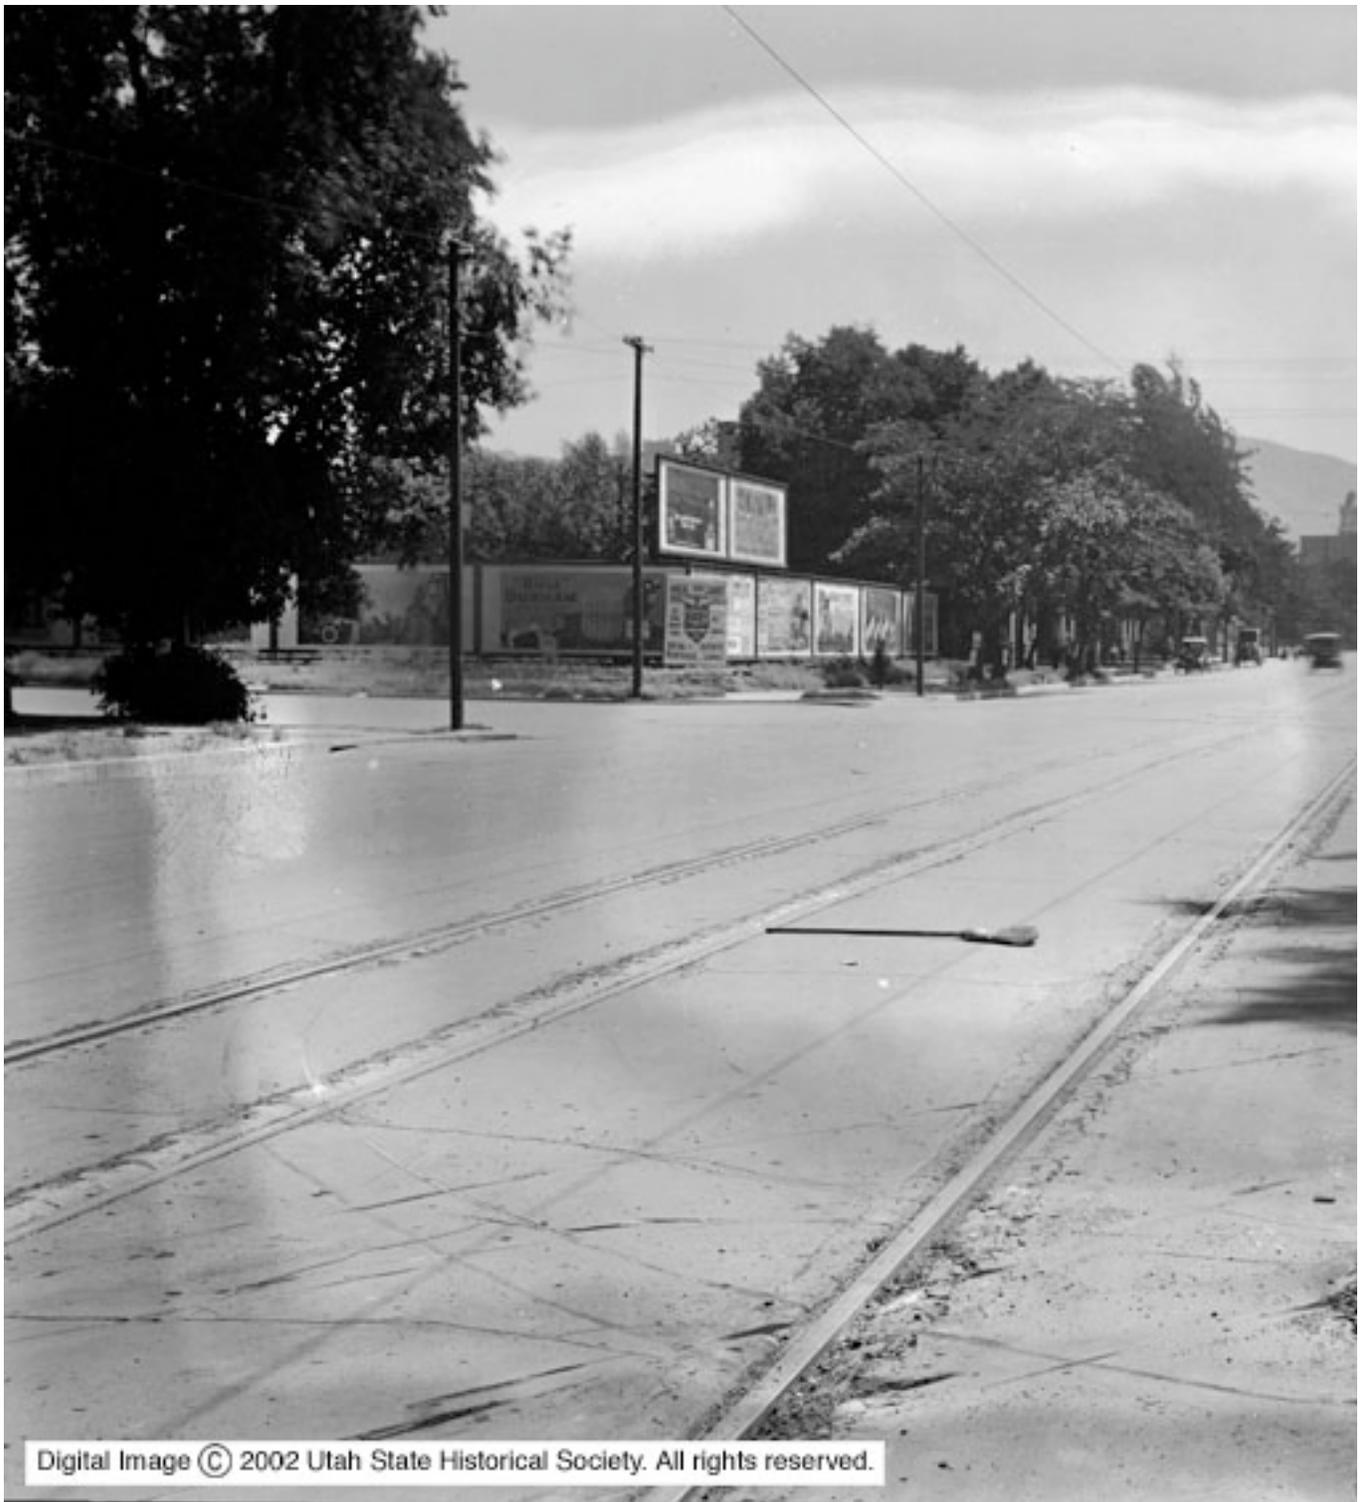
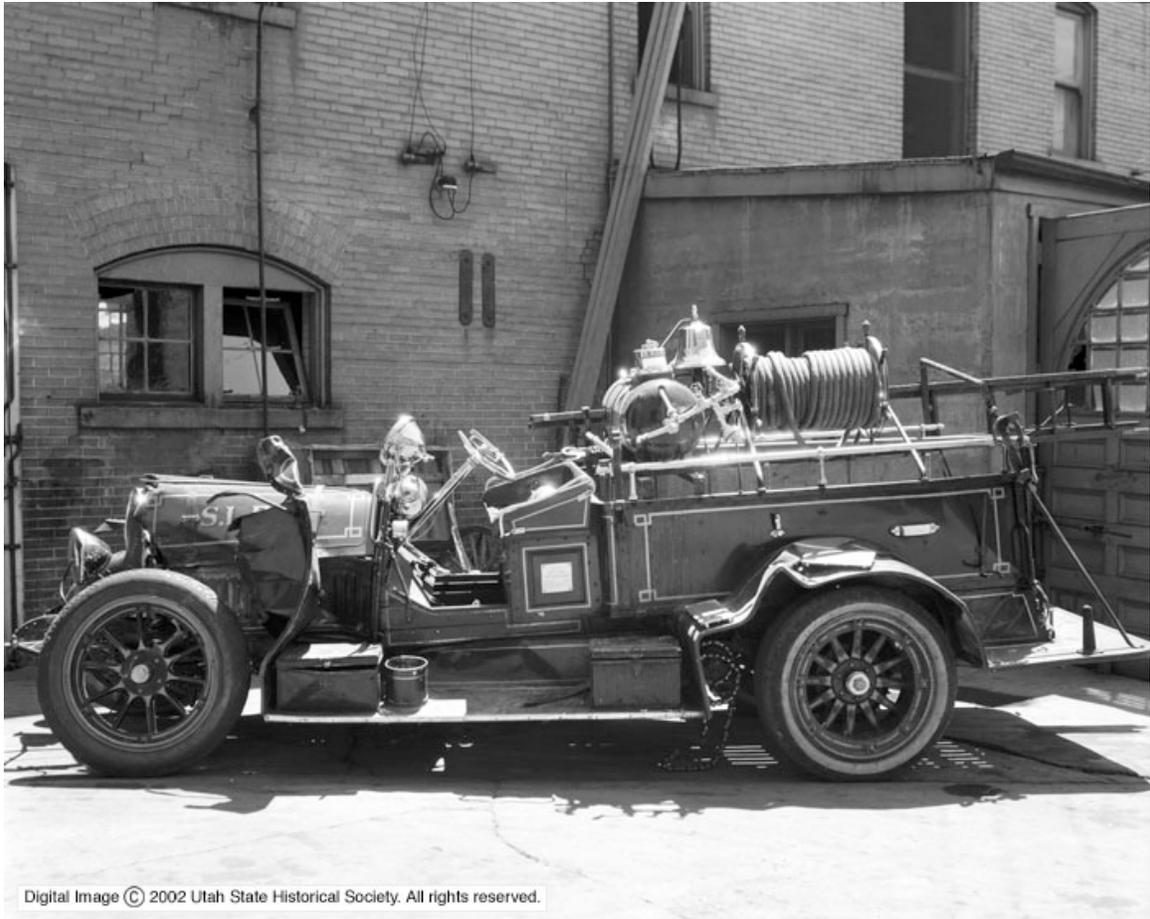
Top and bottom Photos: After the wreck, the Seagrave Engine 2 was towed to the SLCFD repair shops at Headquarters Station.

Middle: Looking east on 300 South to the intersection of 200 West. Gouges in the pavement show where the street car was thrown off of the left (north) tracks and spun toward the right. Notice the lack of tire skid marks. This probably indicates that the fire engine brakes did not lock up.
