Paul Hamilton June 19, 1943

By: Steve Lutz

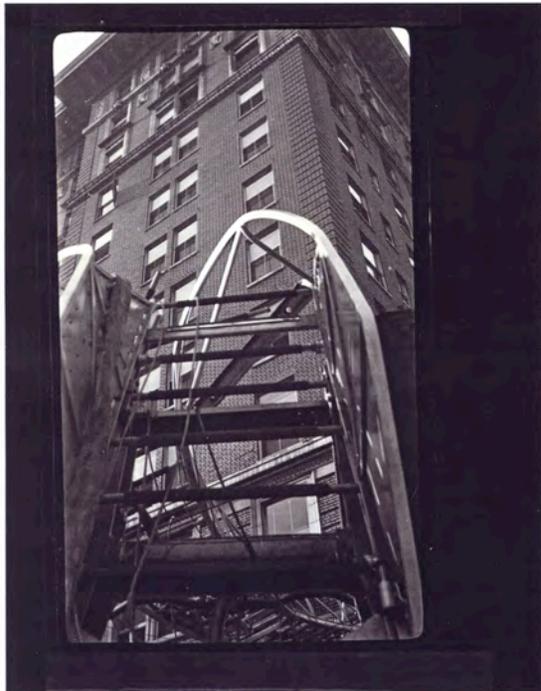
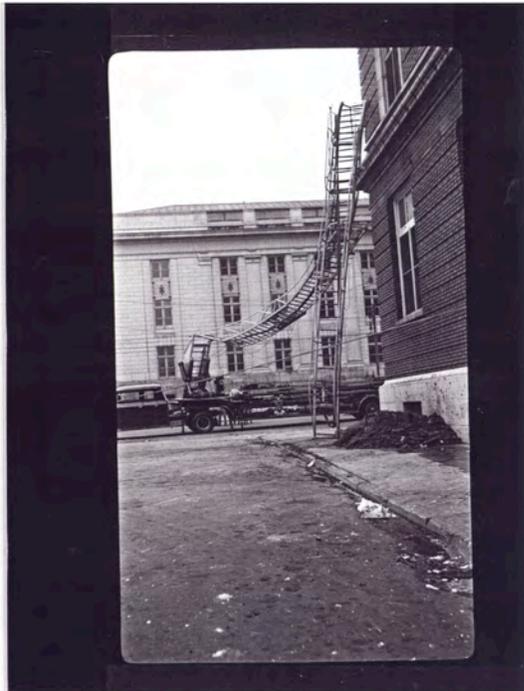
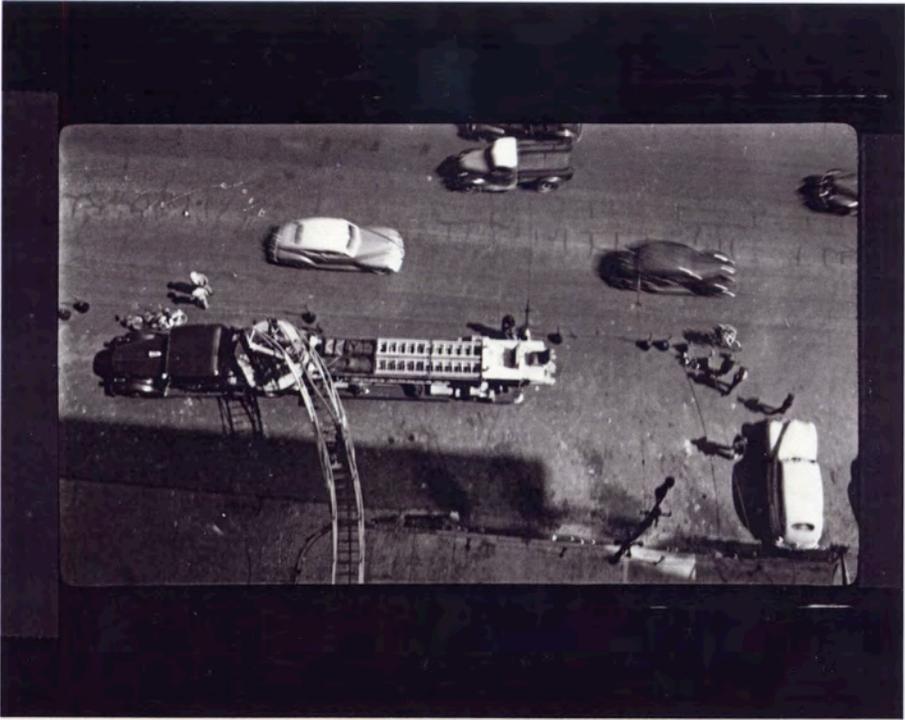
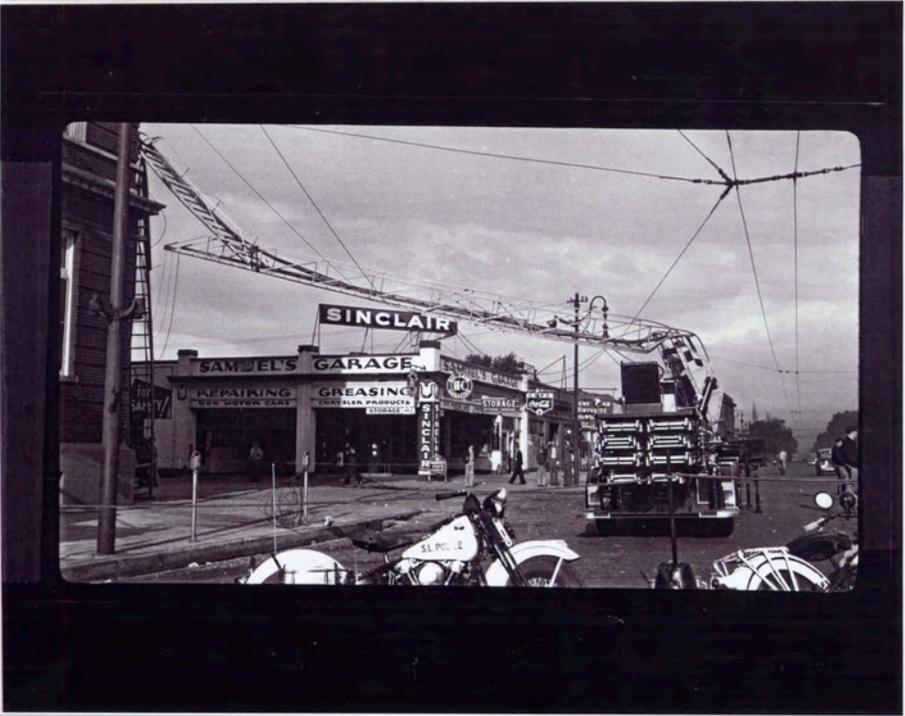
The ladder came to rest in a giant inverted V with a bend at the base and another at the fourth floor with the tip resting on the ground behind the hotel. Hamilton and the injured men were taken to the Emergency Hospital

The Mayor requested that metallurgists and engineers from the U.S. Bureau of Mines examine the wreckage and do a scientific analysis of the failed areas. Using microscopic photography, the scientists, T.R. Graham and James Long documented numerous cracks and poor welds. Porous welds with little penetration and thermal cracks formed at the time of welding substantially weakened the structure. They determined that bad welds in the handrail of the bed section of the ladder failed under tension. They went on to say, "The welding material is gassy and porous... There is a lack of fusion at the overlapping joint... This is the worst condition that can be encountered... cracks and fresh fractures suggest that welding operations produced the course, brittle structure."

Big Dan was new enough that fatigue was not a factor, as the engineers determined. A combination of forces and bad welding were the preventable factors that killed Paul Hamilton and left his wife Florence a widow with two young children, Paul and Joan.

Four photographs taken by investigators the morning after the disaster showing the damage from various angles including an aerial view from the top of the hotel.
